# Report on Laboratory Testing of TI-PROBOARD<sup>TM</sup> (Type AFP/09) for North American Tile Tool Company.

**Date of Report:** June 14, 2010 (Draft)

## Test 1: Composite Panel (Type: AFP/09) Flexural Test

## Test 2: Composite Panel (Type: AFP/09) Pull-out Test

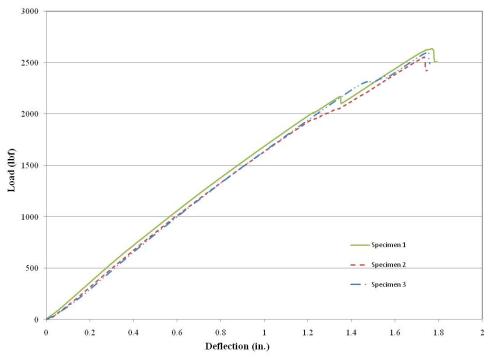
Figure 2: Load-Deflection relation for all specimens

- 6. All three specimens failed suddenly with a splitting noise at an average failure load of 2,597 lbs/ft (Table 1). The load deformation plots for all three specimens are given in Figure 2.

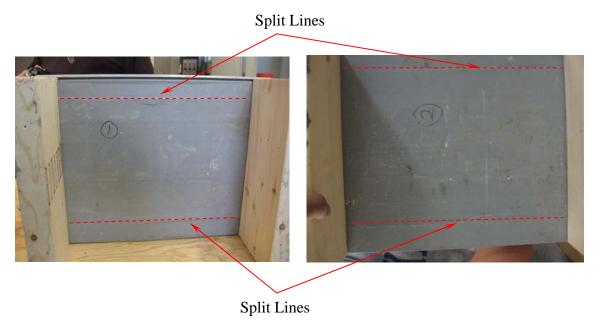
- 7. Splitting of the panels was observed, on all three specimens, underneath the ribs near the edges as shown in Figure 3.
- 8. The panels also had local splitting at screw locations (Fig. 4), but in all cases the panel was yet to break away from the screw when failure occurred under the ribs.

Figure 3: Splitting of panel under ribs next to edge in specimen 1 and 2

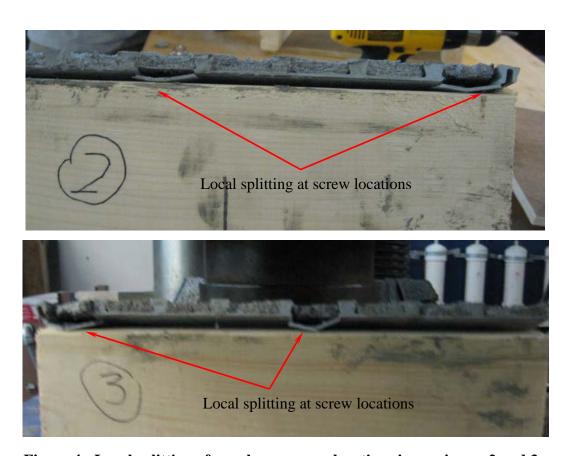
Figure 4: Local splitting of panel near screw locations in specimens 2 and 3

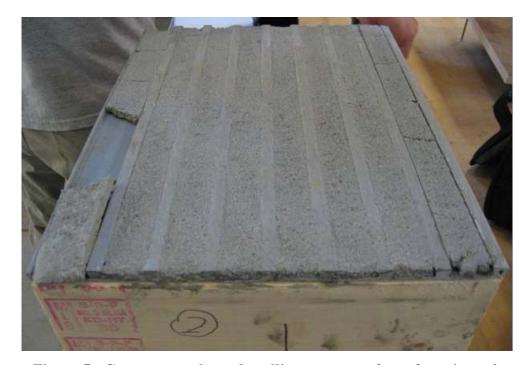
- 9. Cracking and spalling of concrete was observed on the surface (Fig. 5) especially between the ribs closer to the edges on all three specimens.

Figure 5: Concrete cracks and spalling on top surface of specimen 2

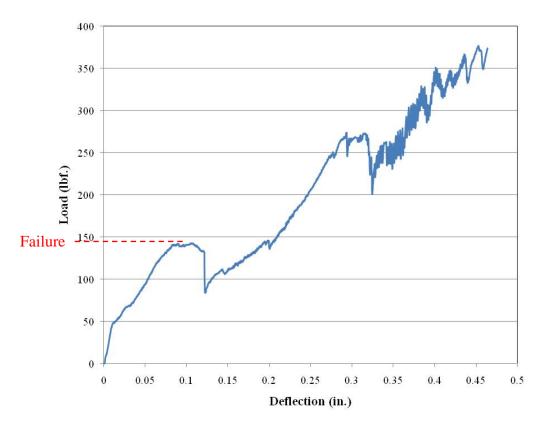
Figure 7: Load-Deflection relation AFP/09 type pull-out specimen

- 6. The loading rate was set at 0.1"/min. Failure was defined as the point where sudden a drop in the load carrying capacity was observed.
- 7. At an applied load of 142 lbf a sharp drop in load carrying capacity was observed as seen in Figure 7. This is believed to be when the panel splits away from the screws at mid span as seen in Figure 8. The load is seen to pick up after the initial drop as the panel cantilevers from the screws at the edge.

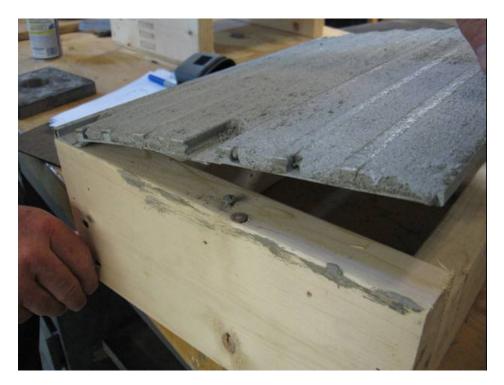
Figure 8: Local splitting of panel at screw at mid-span
