# Report on Laboratory Testing of TI-PROBOARD<sup>TM</sup> (Type AFP/09) for North American Tile Tool Company.

**Date of Report:** June 14, 2010 (Draft)

## Test 1: Composite Panel (Type: AFP/09) Flexural Test

## Test 2: Composite Panel (Type: AFP/09) Pull-out Test

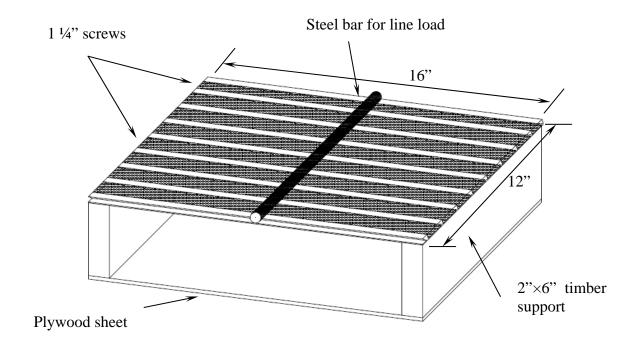
# (a) Specimen layout

- 3. The panels were fastened to the supports by 1 ¼" length screws. Two screws were applied on each side with one near mid-span and the other next to the rib at the edge where the connection to the adjoining rib was placed [Fig. 1 (a)].

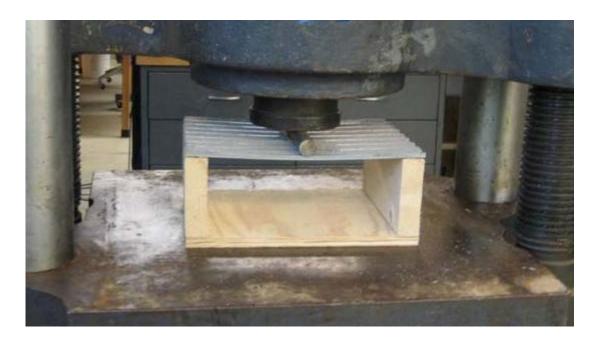
(b) Specimen under flexural load

- 4. A 12"×16" plywood piece was attached to the bottom of the supports to prevent the supports from moving during the loading. A line load was applied on the specimens using a 12" long steel bar as seen in Figure 1.

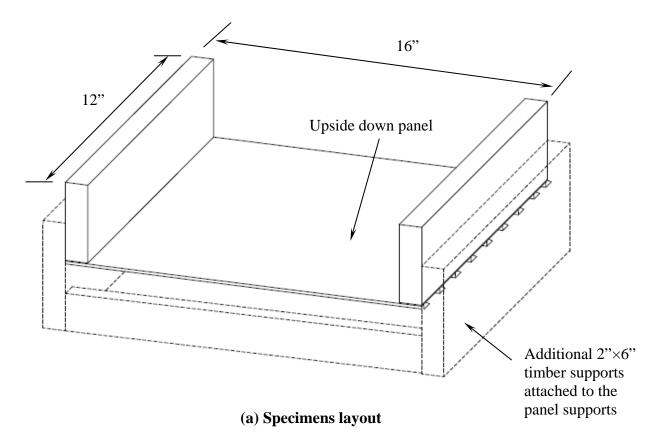
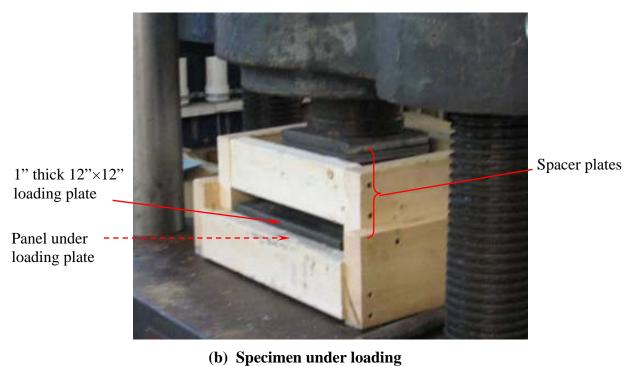
Figure 6: TI-PROBOARD TM panel (Type: AFP/09) Specimen for Pull-out test

- 4. Additional 2"×6" timber supports were attached to the existing 2"×6" timber supports as seen in Figure 6 to set the panel upside down in order for load application. The supports were connected to each other to prevent them from moving during loading.

- 5. 1" thick 12"×12" steel plate was placed on the underside of the panel in order distribute the applied load as a uniform load as seen in Figure 6 (b). The weight of the loading plate as well as the spacer plates used was 117 lbs.

- 6. The loading rate was set at 0.1"/min. Failure was defined as the point where sudden a drop in the load carrying capacity was observed.
- 7. At an applied load of 142 lbf a sharp drop in load carrying capacity was observed as seen in Figure 7. This is believed to be when the panel splits away from the screws at mid span as seen in Figure 8. The load is seen to pick up after the initial drop as the panel cantilevers from the screws at the edge.
